EXHIBIT 4

ADA TROMBLEY v. 3M
CASE-SPECIFIC REPORT AND SITE REVIEW OF OPERATING ROOM
BAY PARK COMMUNITY HOSPITAL, OREGON, OHIO
January 3, 2019

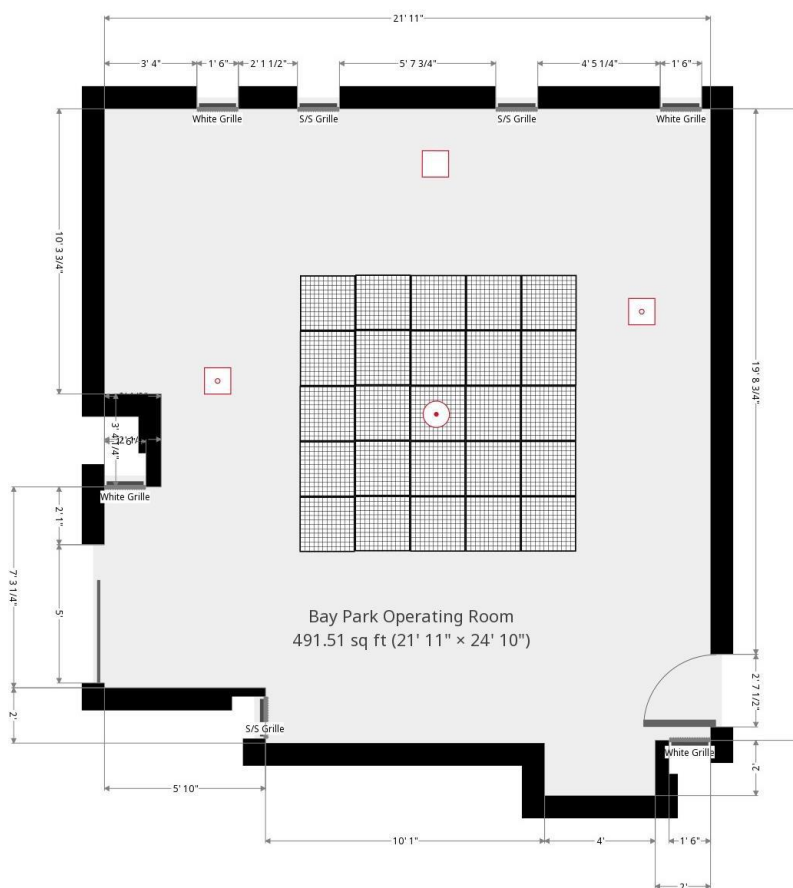
FIG. 1 BAY PARK OR #3 OBSERVED PLAN LAYOUT

The layout of the room provided did not match what I observed at the visit. I measured the room to be 21'11" x 22'10" by 9'10" high. Figure 1 depicts a sketch of the operating room based on what I observed on January 3, 2019. All dimensions are approximate. There was an entry door from the surgical corridor, adjacent to the scrub sinks. There was another door on the opposite wall, that led to the sterile corridor. There were stainless steel cabinets in the room and work counters on the perimeter.

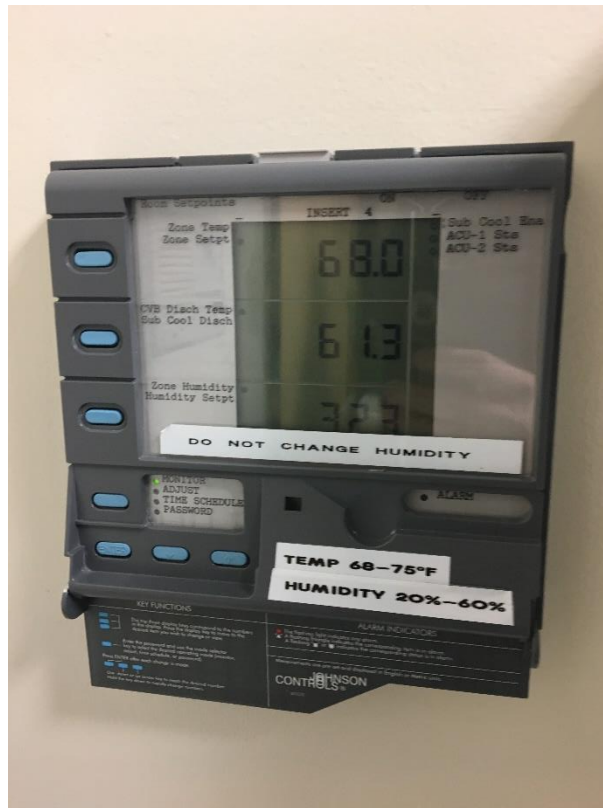
FIG. 2 JOHNSON CONTROLS DISPLAY

There was a Johnson Controls digital display on the wall that at the time of the visit, read 68.0F and 32.3% relative humidity. There was also a reading of 61.3F for "CVB Disch Temp", which I assume referred to a Constant Volume Box Discharge Temperature for the supply air to the room.

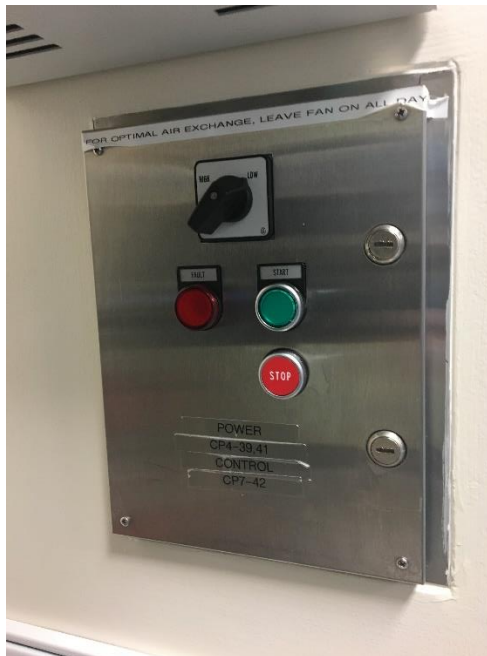
FIG. 3 STERILAIRE SYSTEM CONTROLS

There was a switch on the wall, labelled “Laminar Sub-Cooling Enable/Disable Control”. There were two positions on the switch, “disable” and “enable”. The switch was in the “disable” position during the time of the site visit. Unfortunately, Bay Park Hospital did not provide any information about this system and its impact on airflow in the room. There was another panel on the wall, labelled “Power CP4-39,41 Control CP7-42”. An additional label had been added that read “For optimal air exchange, leave fan on all day”. The panel had start and stop buttons, a fault indicator light and a fan speed switch that had “high” and “low” positions. At the time of the visit, the switch was in the “low” position. This panel appeared to control the two-speed settings of the Sterilair MVCA-1010 Modular Vertical Clean Air System. A Bay Park representative confirmed that during orthopedic procedures the switch is turned to “high.” According to the Sterilair specifications, that setting corresponds to an air discharge velocity of 75 feet per minute.

Another concern is raised by the use of the Sterilaire system at the 75 fpm high setting. ASHRAE 170 requires an average supply velocity at the diffusers of 25-35fpm.^a As I have discussed previously, this range is based on Memarzadeh's work and the interest in preserving the patient's protective thermal plume. Velocities above this level have a higher risk of eroding squames from surgical staff, overcoming the buoyant plume of the open wound and impinging particles into the surgical site, increasing the number of airborne bacteria and the risk of surgical site infections.^b It appears, based on the Sterilaire brochure's claim that it conforms to clean room standards, that the Sterilaire system was designed according to clean room manufacturing concepts that are not applicable to or appropriate for operating rooms.

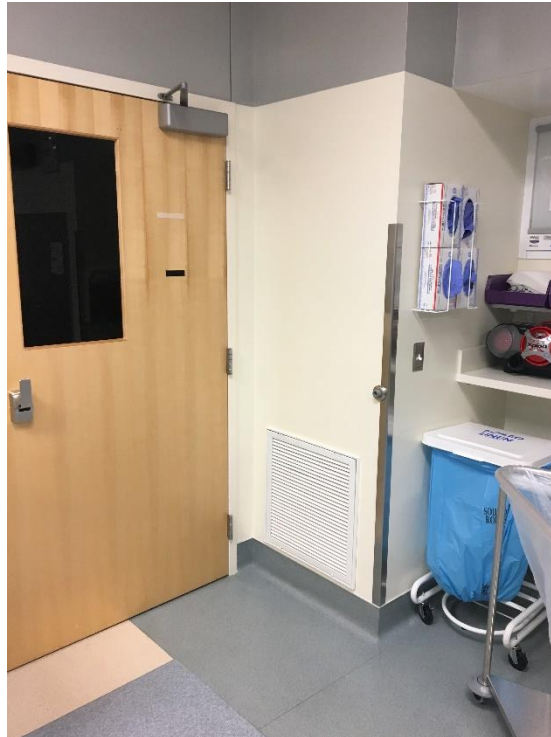
FIG. 4 SIDE WALL SUPPLY GRILLE

There were also an additional four white painted grilles, approximately 18"x18" in size and also 4" from the floor. There was a filter located behind these grilles and it was confirmed on site that air was being supplied into the room at these four locations. The supply grille located nearest the entrance to the sterile core is depicted in fig. 4 below.

The four white grilles that are supplying air near the floor are also a concern for the room air distribution. The air blowing from these grilles so close to the floor will have a tendency to disturb particles on the floor and lift them into the air, creating a greater risk of increased

particles reaching the surgical site. This is especially true of the wall diffusers nearest the head of the surgical table. The placement of wall supply vents near the returns also creates irregular air patterns that are likely to increase turbulence in the room.

- b) A note from Hospital counsel that confirmed the filters behind the side wall supply grilles were MERV 8. Notably, this level of filtration is less than the Bair Hugger unit's rated efficiency of MERV 14.
- c) A note from Hospital counsel that confirmed all grilles in the room were part of the original construction. On that basis I conclude that the HVAC system configuration I observed during the site visit was unchanged from the time of Ms. Trombley's December 2011 surgery.
- d) An operating manual for the Sterilaire MVCA 1010RR Vertical Clean Air System.

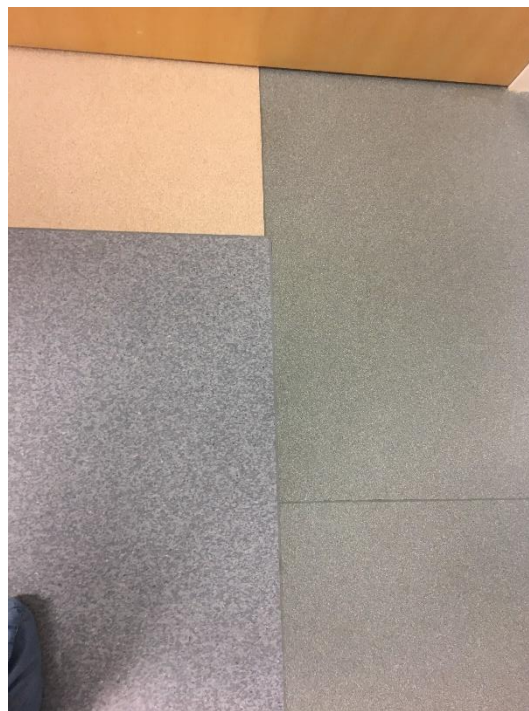
FIG. 5 OR FLOOR SEAMS

The floors were made of a sheet product, with welded seams. FGI Guidelines require that “Floor finishes in operating roomsshall bemonolithic”^c “Monolithic” is defined as formed or composed of material without joints or seams.
